### TEST REPORT

Report Reference No. .... : CTL1702276401-IP

Test specifications / Test standard : Verification test according to sub-clause 13.2 and 14.2.4 of  
IEC 60529:1989+A1:1999+ A2:2013

Test item description..... : LED STRIP

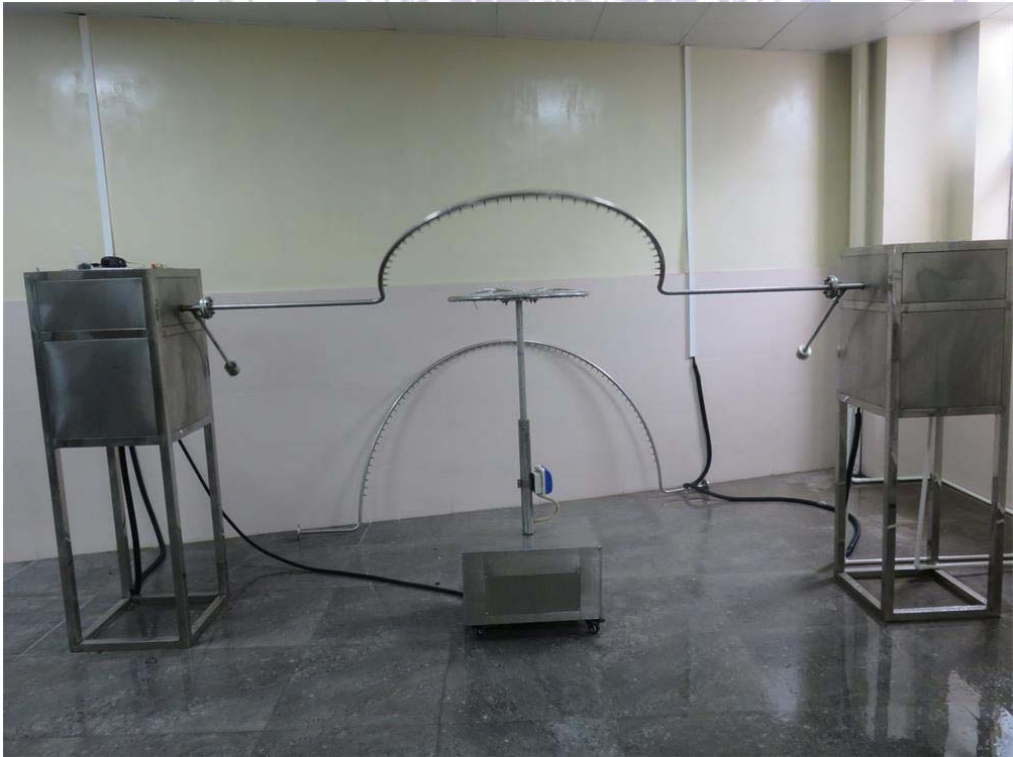
Photo 6 IPX4 Before testing view

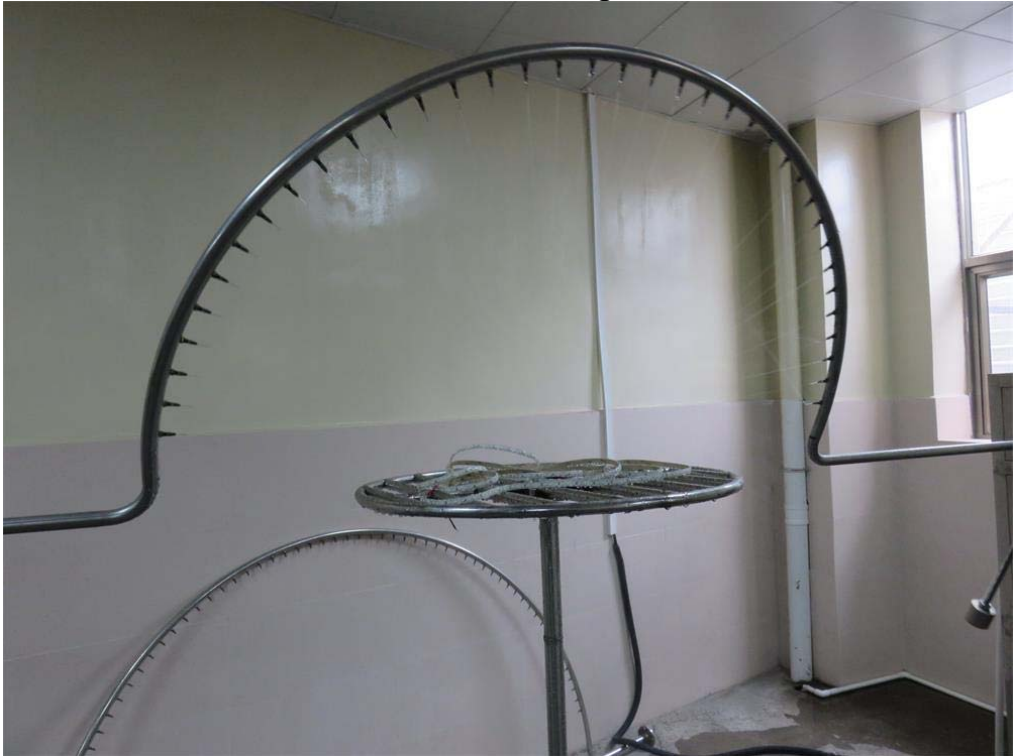
Photo 7 IPX4 Testing view

The oscillating tube has spray holes over the whole 180° of the semicircle.

The tube is caused to oscillate through an angle of almost 360°, 180° on either side of the vertical, the time for one complete oscillation ( $2 \times 360^\circ$ ) being about 12 s.

The number of open holes: 50

Total water flow : 3.5l/min

The duration of the test is 10 min;

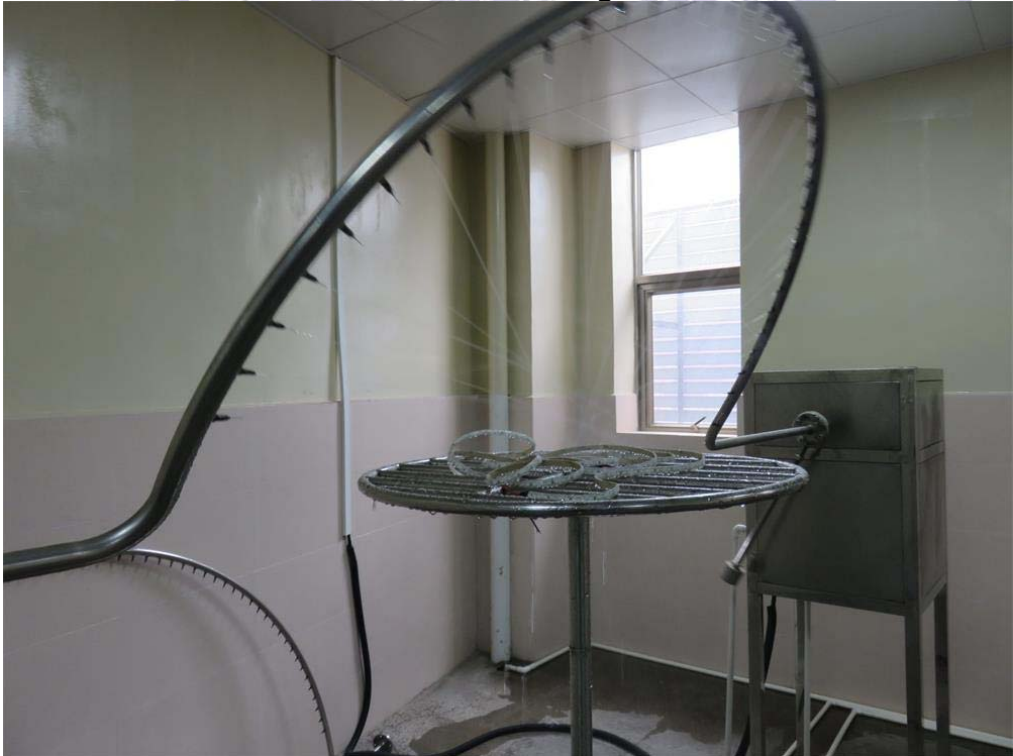
Photo 8 IPX4 Testing view

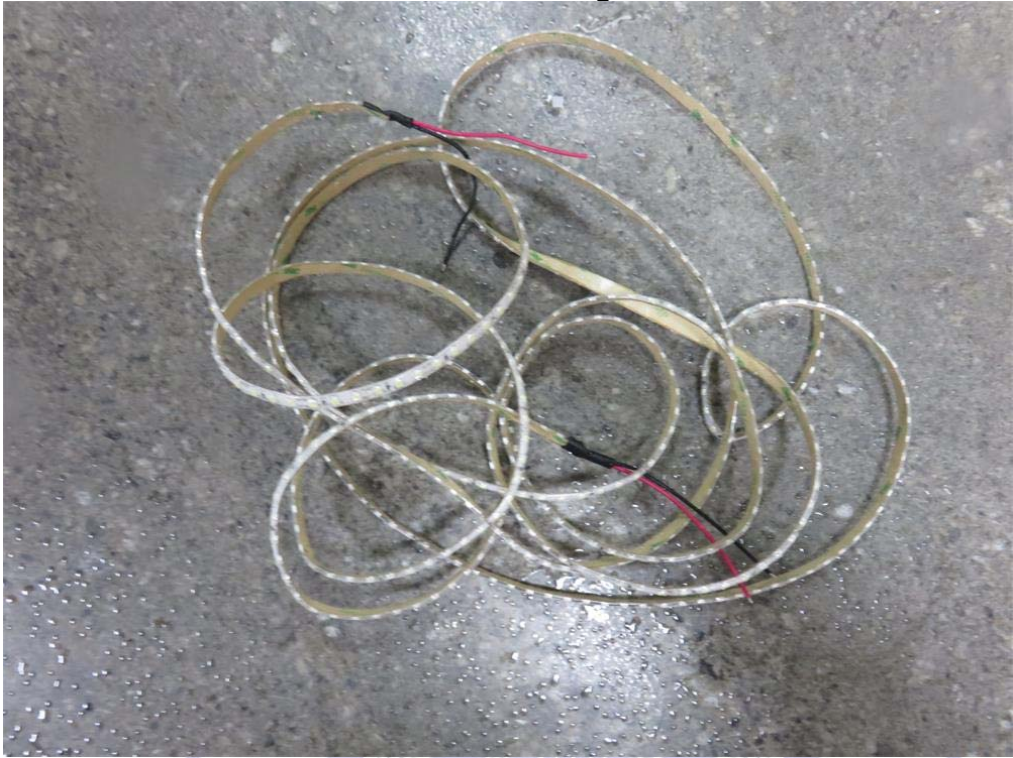
Photo 9 After testing view

| CLAUSE | Verdict |
|---|---|
| <ul style="list-style-type: none"> <li>Any water has entered the enclosure?</li> </ul> | Pass |
